## FITTING OF SHORTING CAP ENDS

<b>Issue date</b>	15 <sup>th</sup> February 2019
<b>Issued by</b>	Dan Randles Head of Policy & Safety
<b>Applicable to</b>	All operational Electricity North West staff and contractors.

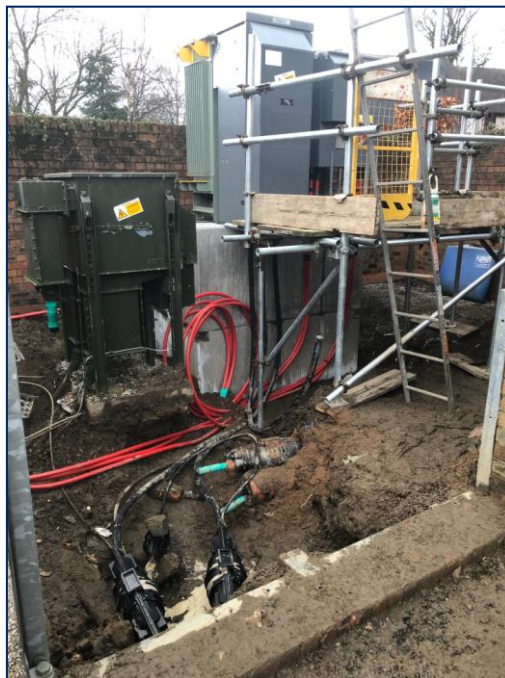
A flashover has occurred during the fitting of a shorting cap end to a low voltage cable in a substation compound. The work being carried out consisted of the replacement of a RMU, transformer and LV cabinet. The trainee jointer carrying out this task has sustained burns and has been hospitalised.

- No assumption should be made that any cable with exposed conductors is dead.
- The cable to be worked on shall be identified in accordance with an approved procedure. Unless the point of work can be visually traced from a point where the conductors are accessible and have been proven dead at that point, it will normally be necessary to open the cable as if it is live and test each conductor with an approved voltage testing device.
- PPE appropriate for the task being carried out shall be worn.
