Issue date	01 November 2019
Issued by	Paul Turner, Head of Safety and Policy
Applicable to	All Electricity North West colleagues and contractors who use MEWPs

Following a daily vehicle inspection of a new Cumberland Mobile Elevated Work Platform (MEWP) in Oldham, the boom was found to be loose. The vehicle was immediately quarantined and a further detailed inspection took place by the manufacturer.

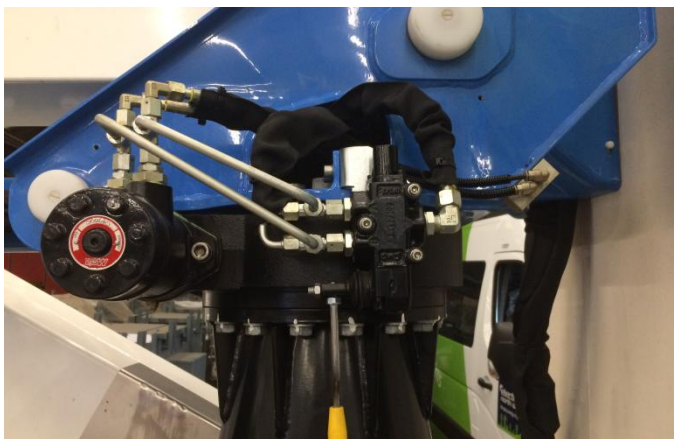
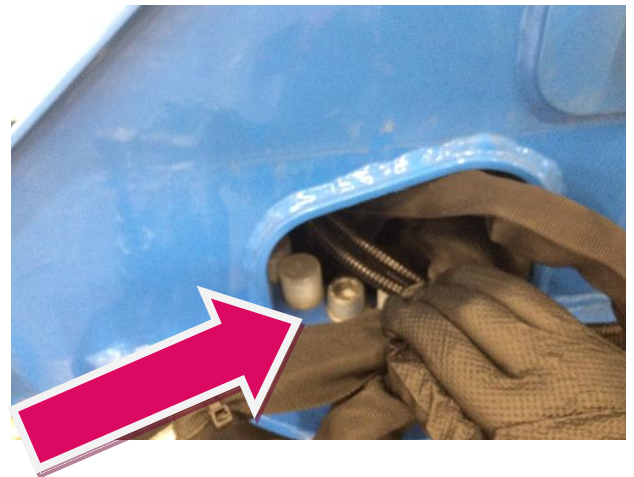
The inner slew ring bolts within the boom (where the hydraulic pipes enter the body of the boom) were loose (see pictures below). Over the last two days, all 30 of the new Cumberland MEWP fleet (registrations starting with either KX68 or KX19) have been inspected by our Transport Team.

The bolts are not easily identified and do not form part of the driver's daily vehicle check. Any irregular movement identified in the body of the boom should be immediately reported to the [Transport Team](#) and the MEWP must not be used.

The interim plan is for the Transport Team to inspect these vehicles on a fortnightly basis until the cause is understood.
