LV Flashover

Issue date	19/11/2020
Issued by	Paul Turner, Head of Policy and Safety
Applicable to	All colleagues and contractors

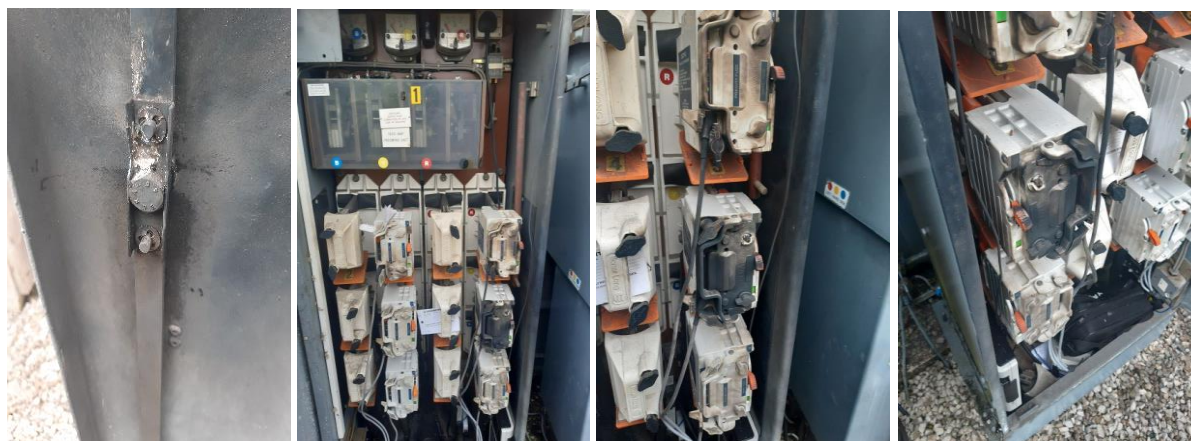
On inspection it was identified the locking mechanism of the cabinet door had made contact with the busbar toggle of the primary fuse holder when the door was closed. This contact ruptured the plastic toggle cover and caused the door to make direct contact with the live metal element of the fuse underneath.

This was a direct connection with the LV busbar and as such was protected by the substation HV protection via the 6.6kv fuse switch.

The HV protection did not operate during the flashover. After a thorough inspection no further damage was identified to the LV Board, with damage to the Bidoyng restricted to the Primary Fuse Holder. The full set of Bidoyngs were safely removed and standard fuses reinserted.

- The Bidoyng had been seated correctly and was fully inserted onto the Yellow phase, however Bidoyngs are much larger than a Standard LV fuse and only just fit inside an LV Cabinet with standard door arrangement.
- The Door Locking Mechanism had aligned perfectly with the Primary Busbar Toggle on the Yellow phase and closed the gap sufficiently to crush it and cause a flashover.
- This type of door sometimes requires a little force to enable the locking handle to spin and close.
- Had the door locked before the contact then there would have been a Flashover inside the LV Cabinet behind the door that was closed and locked.
- Full PPE was worn at the time of the incident.
