Substation flooring

Issue date	04/08/2020
Issued by	Ellen Richardson, Health Safety & Environment Manager
Applicable to	All colleagues and contractors

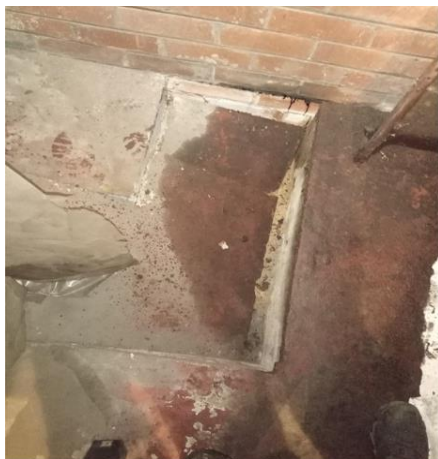
In July 2020 a colleague narrowly escaped injury when a section of the substation floor gave way from underneath them whilst using a ladder. Upon investigation it was identified that a cable trench lay underneath the section of floor where the individual was on a ladder. The trench had been backfilled with a light sand and cement screed.

Historically, a number a cable trenches were backfilled in this way to allow a simple breakout of the trench if needed for operational purposes. Over time, if the sand in the cable trench compacts, a void maybe created between the sand and cement screed presenting the risk of collapse if weight is applied to this area. The practice of backfilling cable trenches today is more robust; the cable trench is blind sanded and topped with chippings. This method does allow for ease of access in the event of an operational requirement but does not present the same risk of a void forming.

When working in a substation, colleagues should assess the flooring before undertaking any work. Where possible avoid standing on any section of flooring where screed has been applied and avoid using a ladder. In the event standing on a section of screed flooring is necessary, a sound test should be conducted before any weight is applied to check if it is hollow underneath. All instances of hollow sections should be reported to CivilTeam-WorkPlanning@enwl.co.uk and the area demarked using barriers or cones.

- Assess your environment, including flooring, when accessing a substation.
- Identify any section of screed flooring and apply defensive behaviours.
- Always assume a section of screed flooring is hollow unless proven otherwise.
- DO NOT use a ladder on any area of screed flooring.
- Report any concerns to the Civil Team and always use barriers or cones to highlight any hazards pending remedial action.
