SPIKING OF HV CABLES

Issue date	15 th May 2019
Issued by	Steve Lockett System Operations Manager
Applicable to	All operational Electricity North West staff and contractors

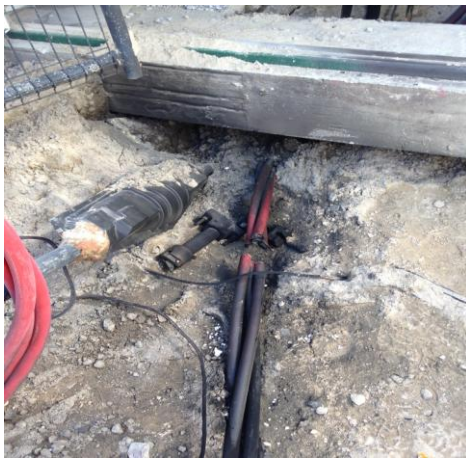
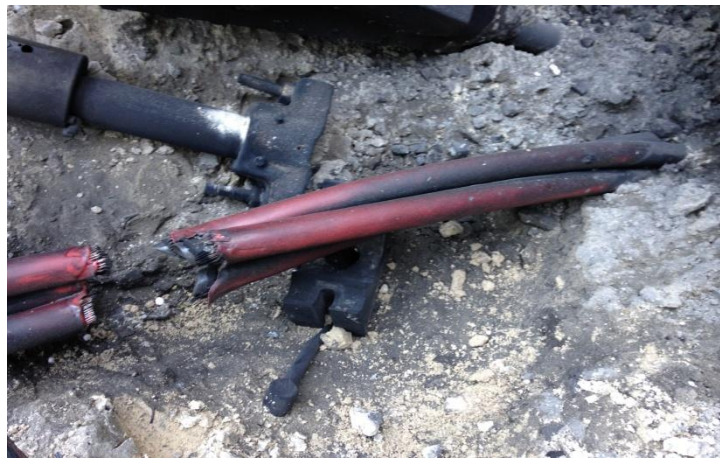
During work to loop in a new substation, a live 6.6kV cable was spiked in error resulting in an explosion and subsequent injury requiring hospital treatment.

An investigations is ongoing, and further details will be issued once know. In the interim, authorised personnel are reminded of the need to follow approved procedures at all times.

- It is the responsibility of the Senior Authorised Person (SAP) to ensure all HV cables to be worked on are identified and proved dead. Ref DSR 5.9.2 and CP606 B02 - 1.2/3.0
- At the point of work, all cables shall be exposed for identification. Ref CP606 B02 - 2.1.3
- An approved spiking procedure shall be used to identify the cable. Ref CP 606 B02 - 1.2/1.3
- If the visual tracing method is to be used, the cable to be identified shall be visually traced along its entire length from a point where it is connected to earth to the point of work. Ref CP606 B02 - 2.3.1
- Where the visual tracing method is restricted, the cable can be identified by placing a ring of suitable material around the cable from a point where it is connected to earth

and passing it along the cable to the point of work. Ref CP606 B02 - 2.4.1

- Before the cable is spiked the SAP shall ensure that the lanyard is extended to at least 7 metres, and all ENW staff, contractors and members of the public are at a safe distance. Ref CP606 B12 - 2.1.3
- The SAP shall control the lanyard operation and spiking procedure. Ref CP606 B12 - 2.9
- PPE identified for the task being carried out shall be worn. Ref Standards for Personal Protective Equipment
