**electricity
north west**

Tap Changer

Acoustic/Vibration-Based
Condition Monitoring System

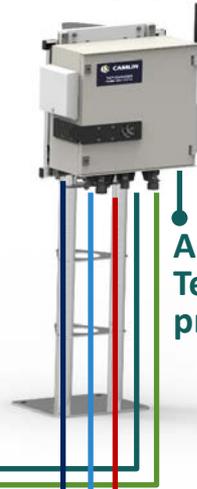
Tap changer monitoring system

2G/3G link

SFTP server collects vibration and current waveform generated by each switchover

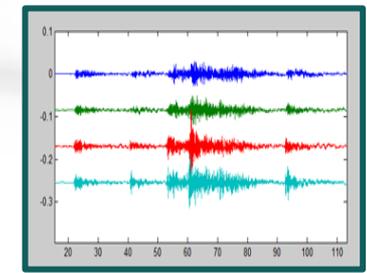
2x temperature probes
(1x tap changer tank temp,
1x transformer tank temp.)

4x accelerometers
or AE sensor

Tap position

4x CTs (1x transformer current,
3x tap changer motor current)

Mains power input

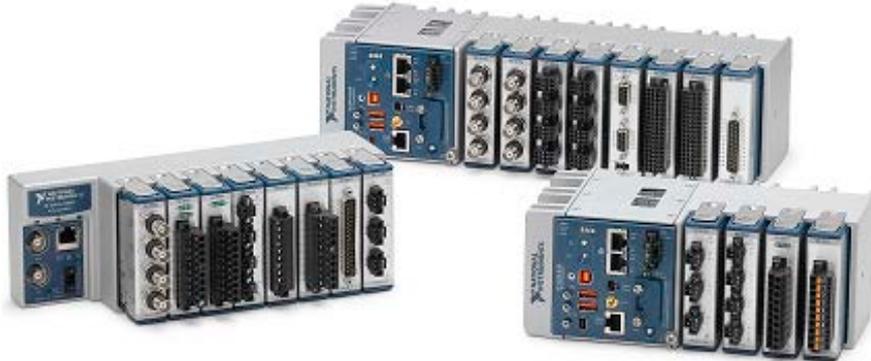
High and not scalable cost

Relatively low sampling frequency (50kHz)

Limited amount of data means **high failure risk of statistical analysis approach**

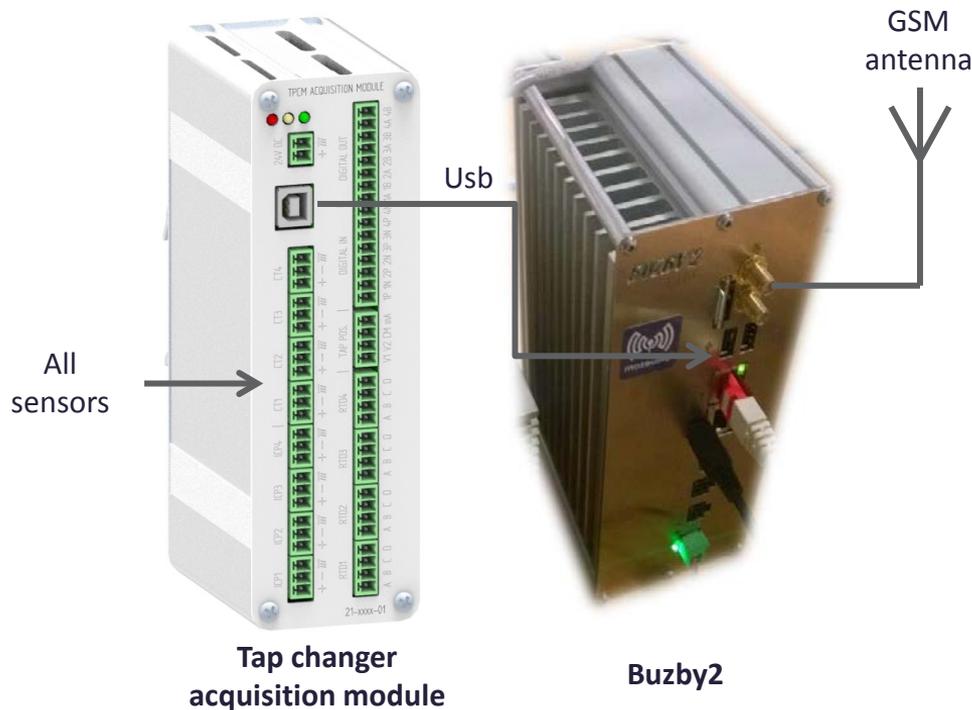
Acquisition model

Complete custom USB acquisition module designed

Flexible 8 channel 24bit 192kHz differential input

Auxiliary isolated analogue input

Auxiliary isolated digital I/O

4 input for RTD temperature sensor

USB interface compatible with any Linux PC using standard drivers

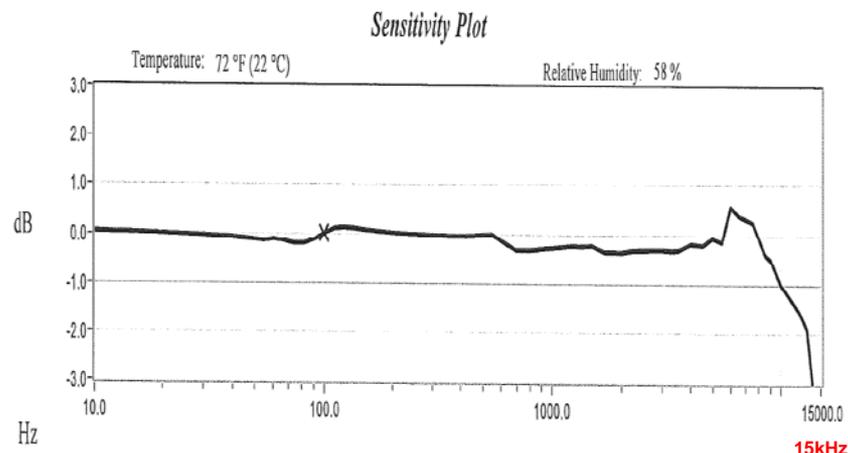
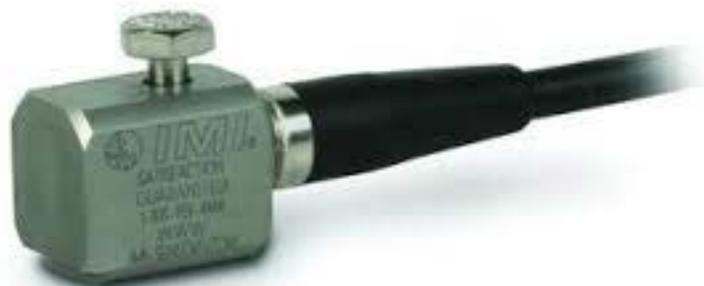
Analysis of mechanical vibration produced by gear and switch

Require sensor capable of vibration detection with phase coherence across spectrum up to 10kHz

ICP Industrial accelerometer used (0.5 to 10-15kHz)

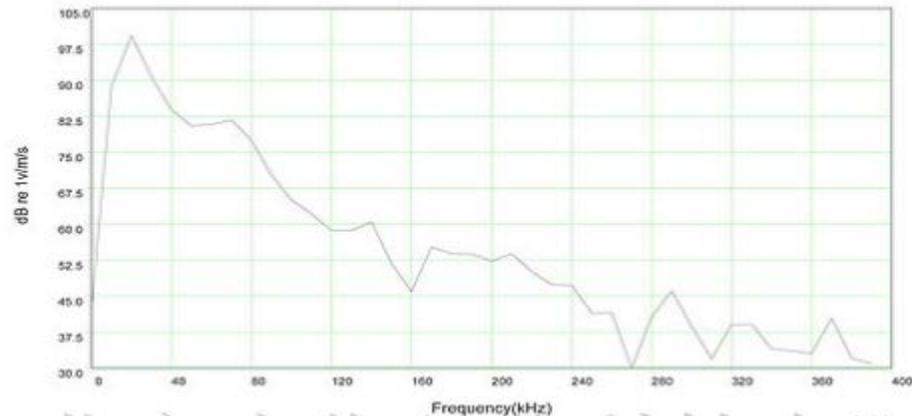
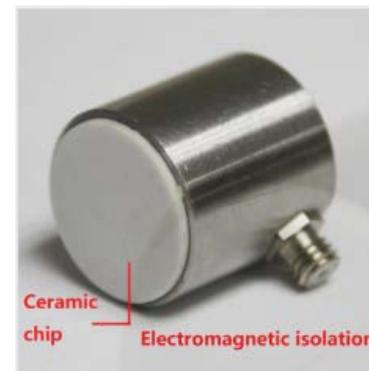
Detection of noise produced by arcing and PD during switching

Require sensor capable of detect high frequency acoustic energy (> 50kHz, where mechanical noise roll off)

Acoustic emission resonating sensor used (15 to 150kHz)

150kHz

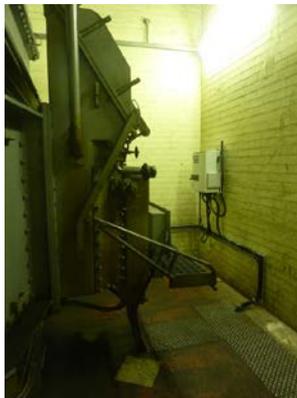
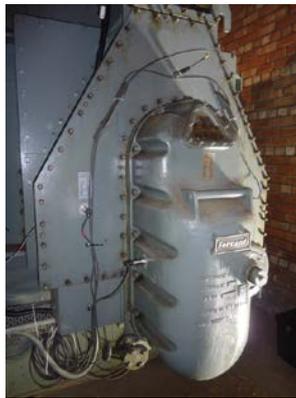
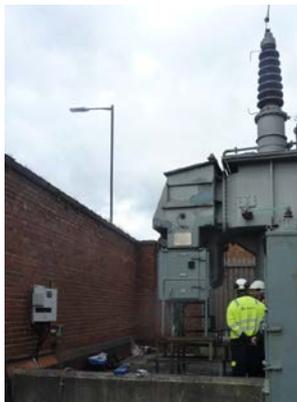
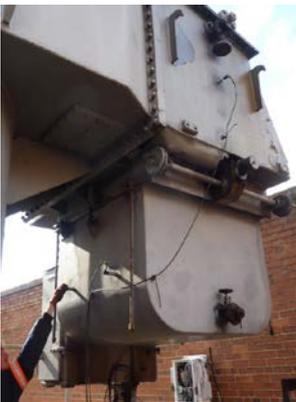
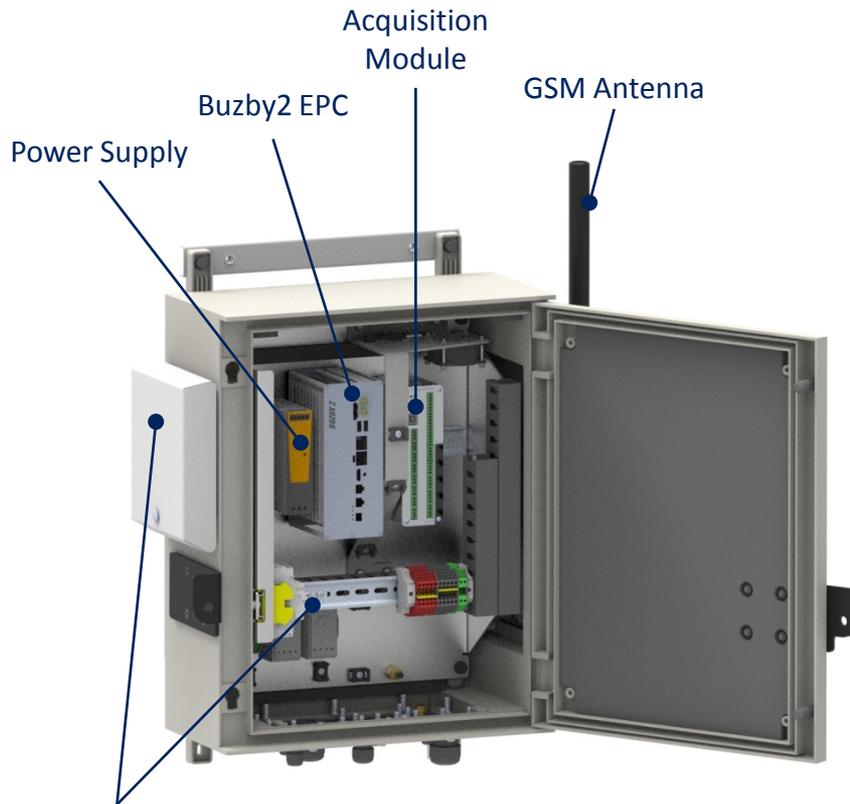
Electro-mechanical system

Cooling and Heating system

Customized enclosures suitable for indoor/outdoor

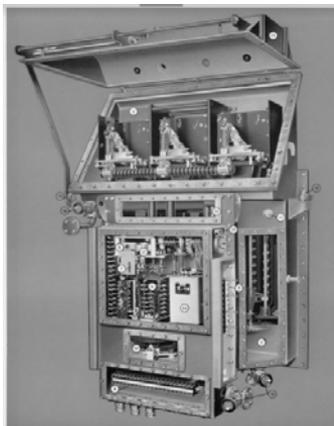
Alpha prototype installation: Winifred Rd

Site: **Winifred Road Primary**

Tap changer type: **Ferranti DC3**

During the selector movement phase of last step of switching sequence 5->4->3 or 3->4->5 arcing noise presence can be clearly heard.

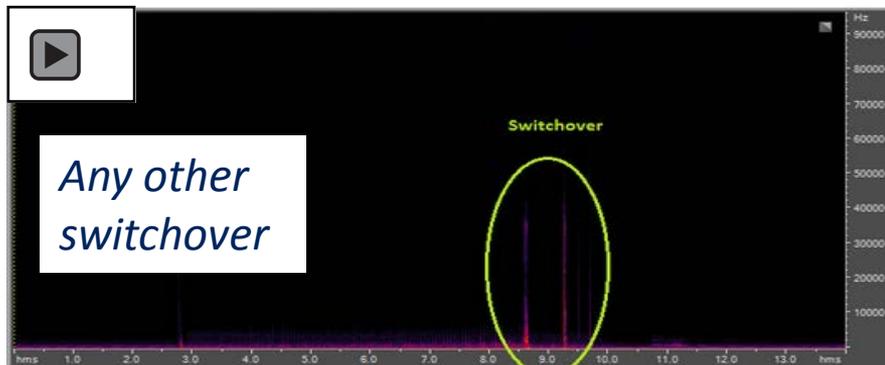
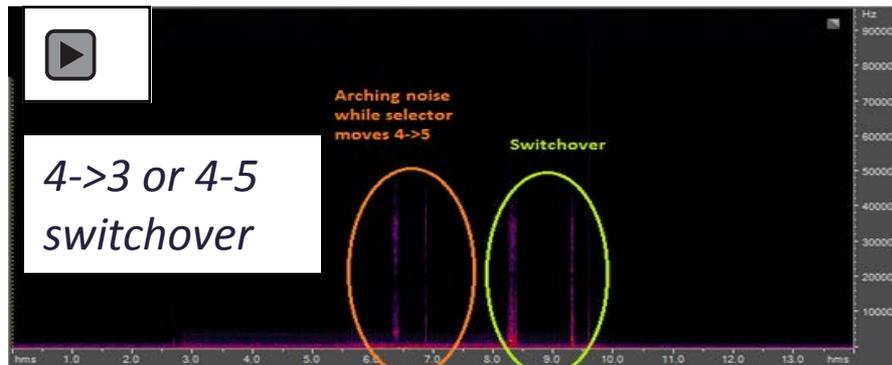
The arcing noise indicates that tap 4 contact of one of the three selectors is excessively worn

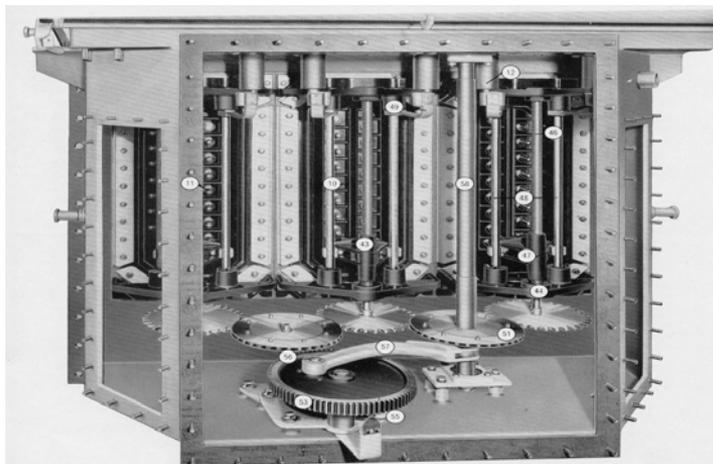
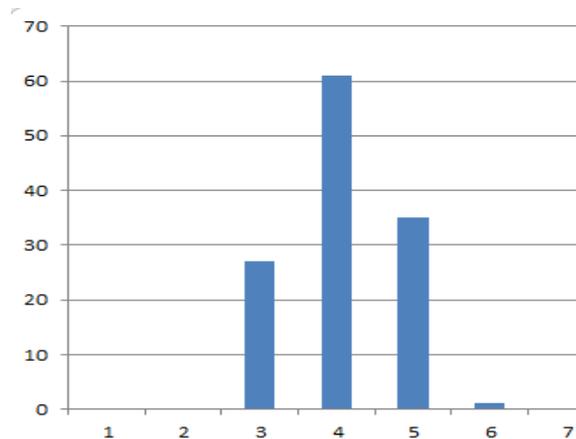
Observing tap usage statistics shows that tap 4 is the most used tap position.
Currently the tap changer is on fixed tap awaiting inspection.

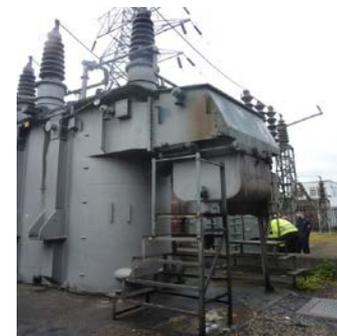
Alpha prototype installation: Altrincham

Site: Altrincham Grid

Tap changer type: **Fuller HS319** ● Recorded anomalous events ● 2/3 time per week always involving tap 8 ● Currently under investigation
