Guidance for Joint Bay Excavation

Unacceptable Joint Holes

Acceptable Joint Hole

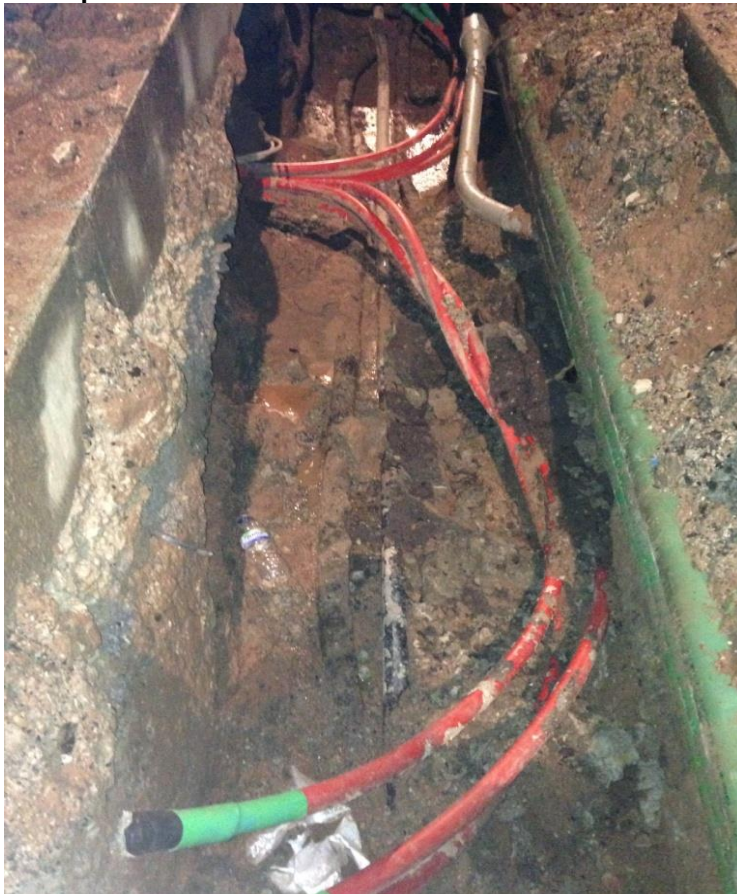
- × Insufficient width for the HV Joint(s) and the Joiner to work safely.
- × All existing cables have not been sufficiently exposed,
- × 300mm below the cables has not been excavated to allow them to be positively identified by signal injection.
- × No safe means of access and egress.
- × Joint hole not shored.
- × No suitable signage and barriers around joint hole or on the approach to the joint hole.

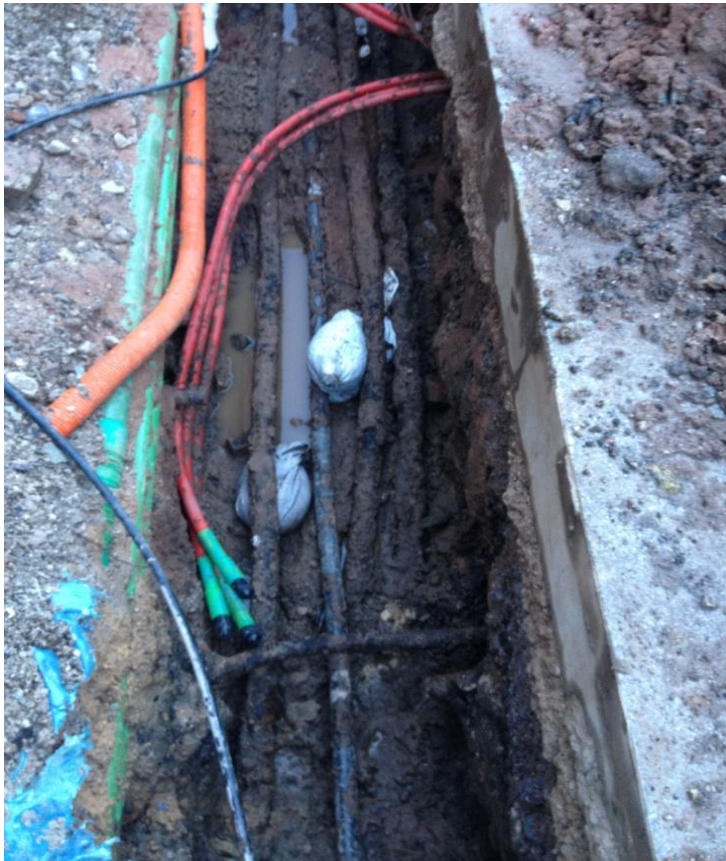
- × Existing Live HV cables have been forced up and supported with sand bags, as opposed to excavating under the cables this is an extremely dangerous practise which could result in death or serious injury.
- × Insufficient width for the joint(s) and the joiner to work safely.
- × No safe means of access and egress.
- × No suitable signage and barriers around joint hole or on the approach to the joint hole.

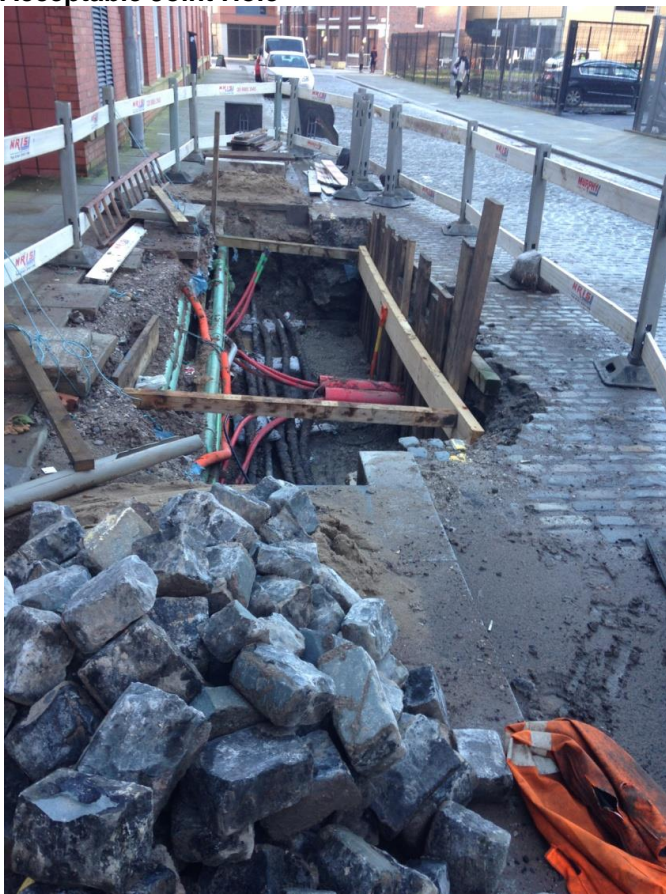
- ✓ Sufficient width for the Joint(s) and the Joiner to work safely.
- ✓ Safe means access and egress.
- ✓ All cables exposed
- ✓ Sufficient excavation under the existing HV Cables to positively identify them by signal injection.
- ✓ The cables which are supported with sandbags, NOT lifted from their existing level.
- ✓ Suitable signage and barriers around joint hole and on the approach to the joint hole.
- ✓ Joint hole shored up.
