NIA ENWL004

Combined Online Transformer Monitoring

NIA Progress Report

31 July 2017

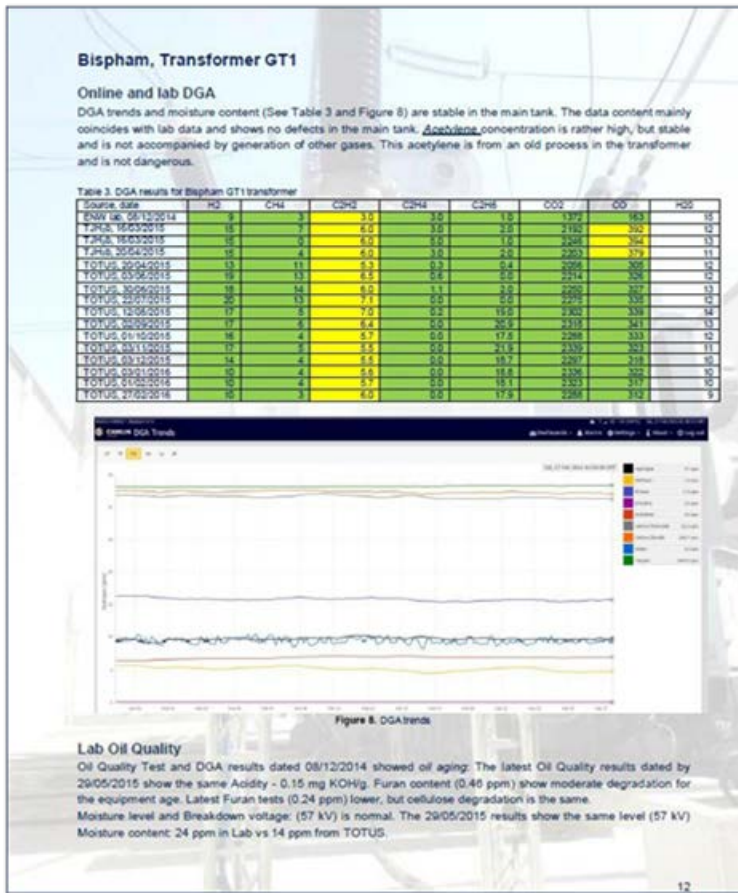
Figure 2: Dissolved gas analysis

The first phase of the project was the development of a dashboard/decision tool which has been successfully completed and a monthly report is produced on the condition of the six transformers. This report consists of a high level red, amber and green status management report. The data visualisation provides the ability to further analyse more in-depth data for each transformer for dissolved gas analysis, bushing monitoring and partial discharge which is trended over a suitable time period.

The monthly data visualisation and reporting has been extended to include all the DGA and PD monitoring equipment that Electricity North West has installed. Examples of the data visualisation and reporting tool are available in the full version of this report on the Electricity North West website.

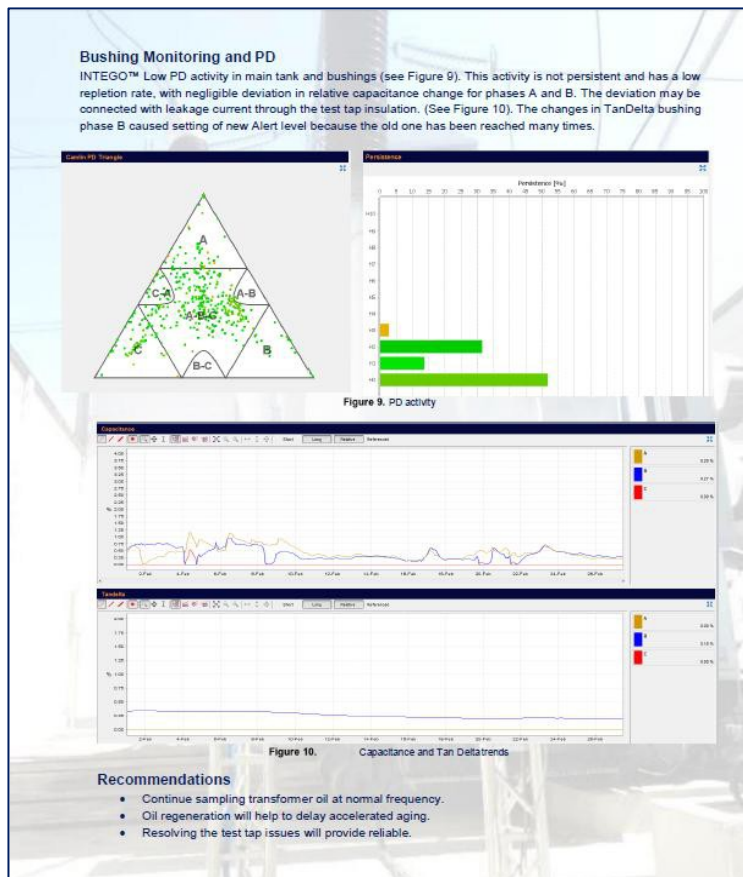
Figure 3: Bushing monitoring and partial discharge
